EFFECTS OF IRON SULFIDE CONTAMINATION & FILTRATION IN A LIQUID TREATING SYSTEM

*Laurance Reid Gas Conditioning Conference
February 26-29, 2024 – Norman, Oklahoma USA*

Nicholas Brownrigg
Howard Energy Partners
16211 La Cantera Pkwy
San Antonio, Texas 78256
nbrownrigg@howardep.com

Orbie Harris IV
Transcend Solutions, LLC
16580 Air Center Blvd., Suite 400
Houston, Texas 77032
orbie.harris@trnsrnd.com

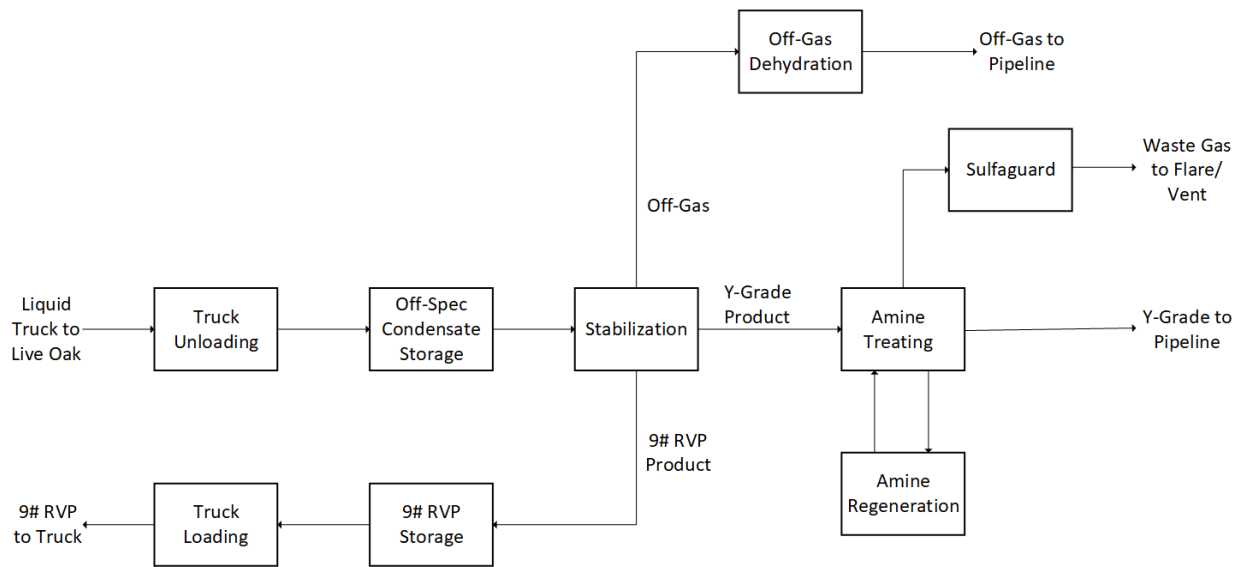
Figure 1 – Simple Block Flow Diagram for Live Oak Facility

The Live Oak facility's processing set up consists of a truck unloading area that allows trucks to offload into several large off-spec condensate bullet vessels. These vessels hold multiple truckloads of off-spec condensate product received and, as previously stated, often contain liquids of varying blended composition. When filled, these Off-Spec Condensate Tanks are pumped to a Stabilizer system that contains a Stripper (pre-frac) Tower and a final Stabilization Tower. The Stripper Tower produces an off-gas product that is compressed and then dehydrated and sent to a downstream pipeline. The Stabilization Tower produces a 9 psi RVP stabilized condensate product off the bottom of its reboiler and Y-grade NGL product from the reflux of the tower. The 9 psi RVP stabilized condensate is stored in atmospheric storage tanks, and the Y-grade NGL is pumped to a downstream pipeline.

Because H₂S is typically present in the loads received at the Live Oak facility, the Y-grade product often sees an unacceptable amount of H₂S out of the Stabilization Tower as it pertains to meeting pipeline-grade product specification. For this reason, an NGL Amine Treater is installed downstream of the Stabilization Tower for the Y-grade product before it is sent to pipeline. The NGL Amine Treater consists of an NGL Amine Contactor Tower, and an amine regeneration system for the effluent rich amine. In the NGL Amine Contactor, the Y-grade product is passed through an amine column, where the amine absorbs any H₂S or CO₂ present. Once treated, the Y-grade is considered on-spec and can be sent to pipeline using the downstream pipeline pumps. The rich amine exiting the bottom of the NGL Amine Contactor is sent to the Amine Regeneration system to remove the absorbed H₂S and CO₂ components, so it can be reused downstream in the amine contactor for further absorption. The rich amine is flashed down to a lower pressure to free

any entrained light hydrocarbons, which are recovered as fuel gas within the process. The amine is then passed through a series of filters to remove any remaining entrained hydrocarbons, debris, or solid particulates (which will ultimately be the discussion of this paper). After filtration, the rich amine is sent to a still tower where CO₂ and H₂S components are boiled off in a reboiler at high temperature. This acid gas stream is scrubbed in a Sulfaguard unit (H₂S scavenger system) to remove H₂S before being flared/vented, and lean amine leaves the reboiler before being cooled and recycled to the amine contactor tower. For the purposes of this paper, it is important to note that the equipment in the amine system predominantly consists of carbon steel material of construction on all major vessels and piping.

The Live Oak Facility is designed to process a capacity of 10,000 bpd of inlet condensate from the off-spec condensate storage and produces a varying amount of 9 psi RVP product and NGL depending on inlet condensate composition. The amine system is designed to handle 7000 bpd of NGL and has a design amine flow rate of 20 gpm.

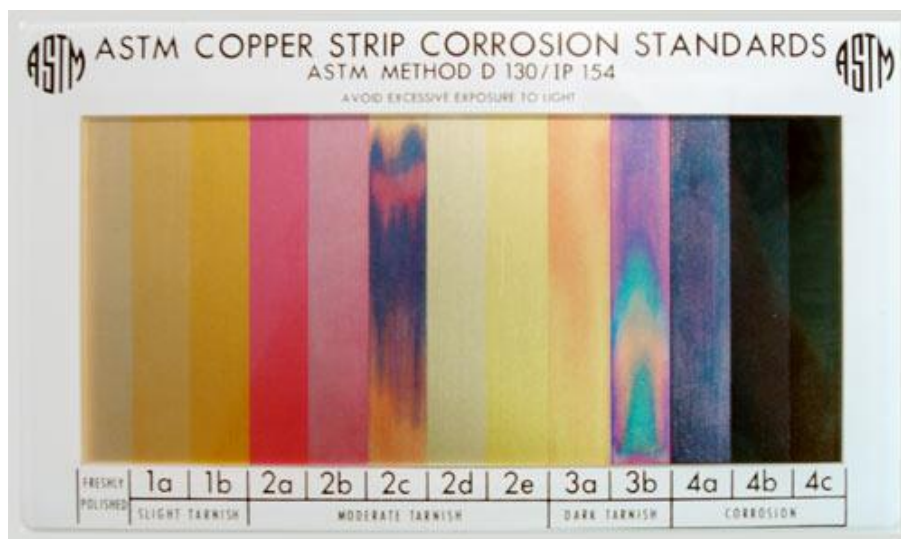
Figure 2 – ASTM Copper Strip Corrosion Standards

The copper strip corrosion test is an ASTM standard test used to qualitatively measure for the presence of sulfur species in the Y-grade; if the copper strip inserted into the Y-grade is tarnished, it indicates that there are sulfur species in high enough concentration within the Y-grade such that it does not meet pipeline specification, while no-to-minimal tarnishing indicates a pass of the test. Y-grade is within specification if it meets 1A or 1B standards, per the ASTM copper strip corrosion standard chart in Figure 2.

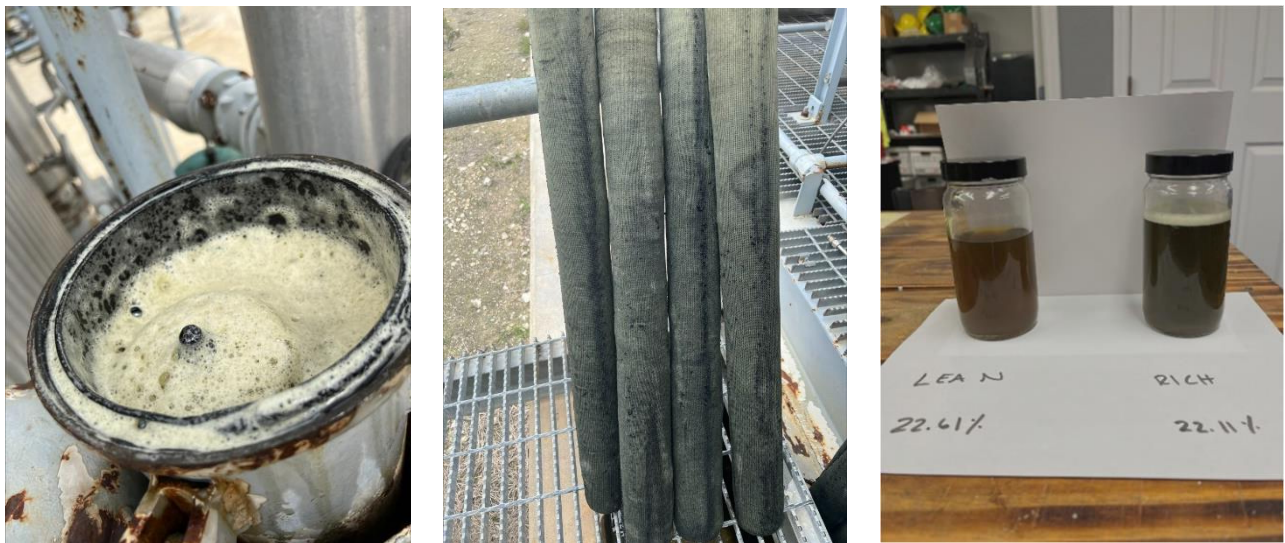
Figure 3 – Amine Foaming in Pre-Carbon Filter, Black Debris on Filter Cartridges, and Amine Samples

When the copper strip failures and operational issues in the Amine Regeneration system reemerged in late 2022, operations also noted that the Amine Contactor and Amine Still sight glasses were filled with a black debris, that the Pre-Carbon Filter on the Amine Regeneration skid was full of foam and several of the previously spent filtration cartridges contained black debris. Additionally, amine samples appeared to have a very dark hue, both in samples collected from the lean side and rich side of the Amine Regeneration system.

Knowing that iron sulfide is constantly produced during the reaction of the amine with the NGL liquid helped to put into perspective why the black debris reformed in the Amine Still after its cleaning. Additionally, from the literature, iron sulfide particles in a high enough concentration in an amine system is known to cause severe foaming in amine and lead to amine process upsets, similar to what was being observed in the Live Oak Amine Treating system, particularly in the Pre-Carbon Filter during changeouts as noted in Figure 3.

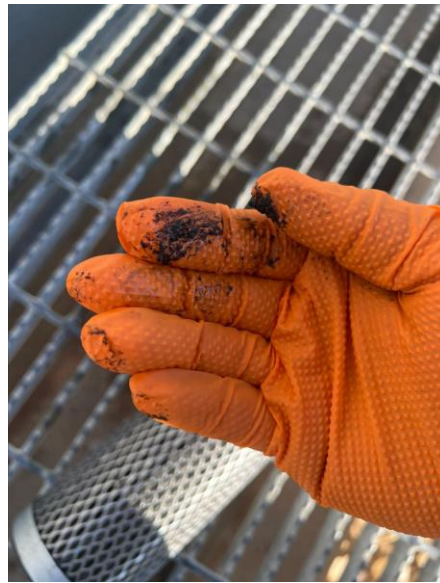
Figure 4 – Solid Black Debris Recovered from Amine Regeneration System

While the source was still unknown, the buildup of the black solid debris in the Amine Contactor and Amine Still was a cause for concern, and it was determined that the Live Oak facility would take a brief shutdown to open the Amine Still and clean out the black debris present in the vessel. After cleaning the Amine Still of the black debris, the facility consistently passed the copper strip corrosion test and saw no operational issues again for approximately one month. Once the copper strip corrosion test failures and operational issues returned, it was noted by operations staff that the Amine Still again was filled with black debris.

The presence of the black debris throughout the Live Oak facility's Amine Treater system and its reappearance after being cleaned out led to the HEP's discovery of literature (referenced in the References section at the end of this paper) that discussed the fouling of Amine Systems. The papers discussed a black build up in amine units treating H_2S commonly referred to as "shoe polish". The description of this "shoe polish" material was similar to what HEP was seeing in the Live Oak Amine Treater. While "shoe polish" tends to have a more gummy consistency (indicating the presence of other contaminants that give it this consistency), the effects of "shoe polish" mentioned in the paper and the coloring matched what was being seen in the Live Oak Treater.

From the literature, it was determined that this "shoe polish" material forms due to iron sulfide particles that are created during the reaction of the amine with H_2S in the liquid NGL being treated. In the reaction of the amine with the H_2S in the liquid NGL, sulfur ions can also react with iron ions present in the steel used in the piping and vessels of the Amine System to form iron sulfide solid particulates. In many systems, these iron sulfide particles form on the sides of the vessels and piping in the amine system and form a protective layer against corrosion due to sulfur within the unit. However, if velocities of fluid moving through the vessels/piping is high enough, the iron sulfide particles can be washed away, or not allowed to settle, and can circulate throughout the system, contaminating amine and leaving the steel prone to potential sulfur corrosion.

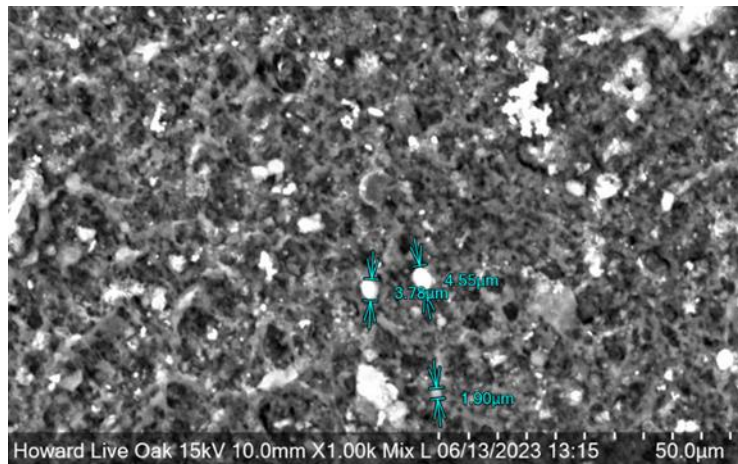
Figure 5 – SEM Particulate Sizing

- A magnetic separation test was performed on the dried solids using a strong magnetic source. It was determined that the solids were ferrous in nature, due to their affinity for the magnetic source.
- Scanning Electron Microscopy (SEM) was performed on the filter elements collected from the Live Oak site, and the particle size was determined to range between 2 microns to greater than 10 microns. See Figure 5.
- Energy Dispersive X-Ray Spectroscopy (EDS) was performed on the filter elements collected from the Live Oak site. Analysis showed S and F with an atomic percent of 66.3 33.7%, respectively, indicating a form of ferrous sulfide was present in the system. See Figure 6.

These results indicated that the black debris recovered was likely to be metal sulfide particles.

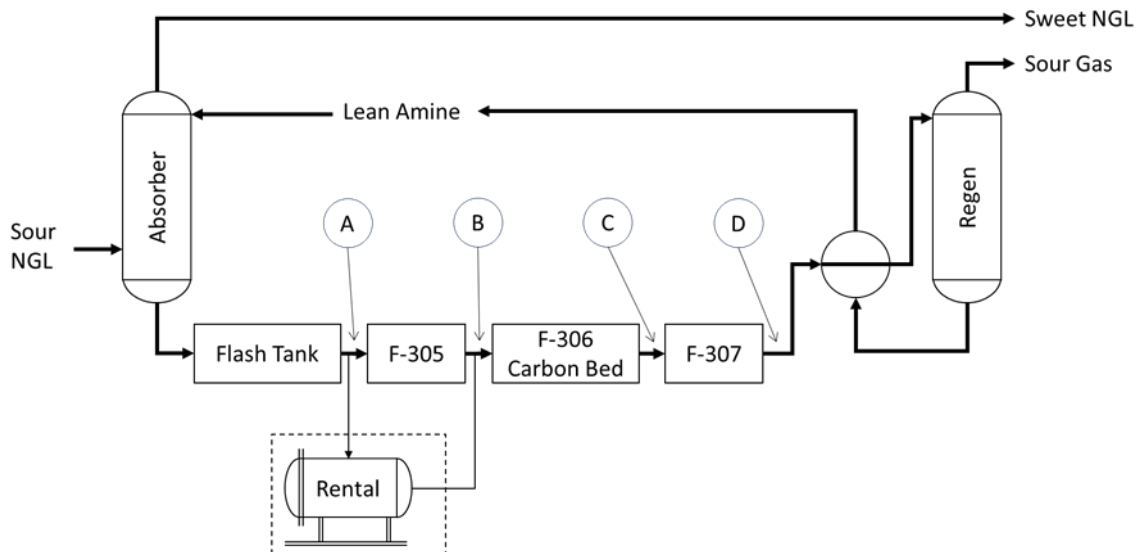
Figure 7 – Live Oak Filtration Flow Diagram with Sample Locations and Rental Vessel Tie-In Points

Transcend Solutions proposed a two-step solution for HEP's amine unit. The first step was to utilize a filtration vessel from Transcend's rental fleet to help remediate the iron sulfide problem in the near term. The second step was to design a fit-for-purpose filtration unit that could handle the particulate load present in the system, while minimizing the amount of work required from the HEP operations team for filter changes. A process overview, showing where samples for testing were collected, and rental vessel tie-in locations can be seen in Figure 7.

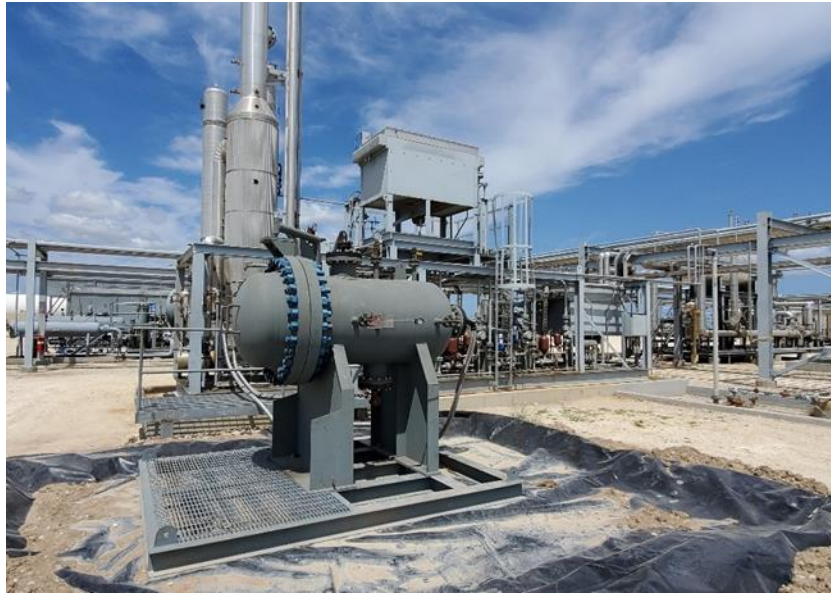
Figure 8 – Installed Rental Vessel at HEP Live Oak Facility

The rental filter provided by Transcend Solutions to operate in lieu of the existing Pre-Carbon Filter is shown in Figure 8. The rental filter was approximately 200 gallons in volume with thirty-

six (36) 10-micron Tetra Endur coreless filter elements, utilizing high efficiency Novacel™ media. The rental unit was significantly larger than what would be custom-designed for the permanent filter solution, which would be installed at a later time.

With the rental vessel online, the amine stream began to clean up and allow the Live Oak facility to return to 1A/1B copper strip test results. In approximately 3 weeks, the Live Oak facility was able to return to full process capacity.

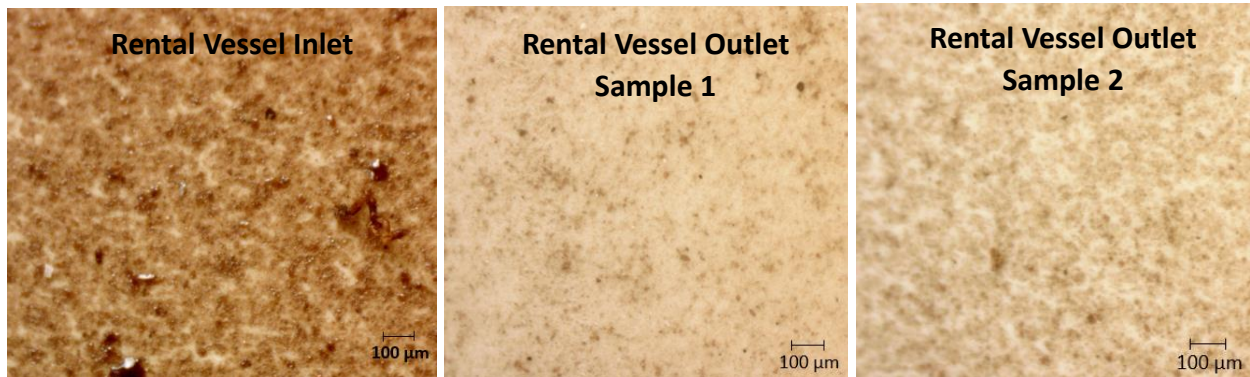
Figure 9 – Rental Vessel Gravimetric filters collected on 12-14-23. Image at 4X power

Unit / Vessel	Inlet (mg/L)	Outlet (mg/L)	Removal
Rental Vessel Sample 1	10.7	0.5	95%
Rental Vessel Sample 2	10.7	0.4	96%

Transcend Solutions then provided a custom-designed permanent filter for the Amine Treater at Live Oak to replace the existing Carbon Pre-Filter and rental filter previously used. This filter was designed to minimize piping and skid rework at the Live Oak site, which in turn helped keep installation costs low. Additionally, the size and number of elements in the filter was optimized to give the operations staff at the Live Oak facility ample time between changeouts. While final installation of the permanent filter was not complete at the time of the writing of this paper, the permanent filter is designed to achieve a removal efficiency of 99.98% on all particulates greater than 10 microns in the amine stream. This filter will be installed on the Live Oak amine regeneration system once fabricated to provide ample iron sulfide removal from the amine stream.
