# Fabric Expansion Joints: The Modern Choice for Coal-Fired Power Plants

*Historically, metallic expansion joints were the only option for the extreme temperature, pressure, and conditions of many applications in coal-fired power plants. Metallic joints could handle 750° Fahrenheit, for example, while fabric joints could only manage 350°F.*

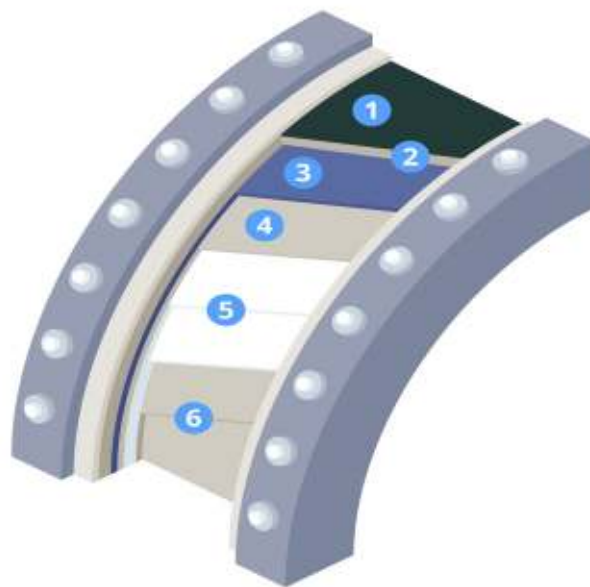
Most fabric expansion joints consist of several layers with varying properties that provide compounding benefits as well:

Single layer belt with the highest temperature capability for a gas seal layer. Fluoroplastic belts can handle a continuous 600°F.

Vapor barrier for applications that may cycle through dew point

Fiberglass insulation thermally bonded to the outer cover to protect from heat degradation and eliminate “hot spots.”

Vermiculite-coated fiberglass fabric acts as an insulator and increases expansion joint strength and durability. Wire mesh layers may also be added for increased durability and abrasion resistance.

The presence and thickness of this layer(s) is determined

by the system temperature to ensure that the heat transfer from the flue gas is reduced to a point less than the maximum allowable temperature of the vapor barrier (600°F) and cover.

Close weave material binds the belt together, acts as an insulator, and adds strength for handling and service. A metal flow liner is required in applications where there is abrasion.

Together, a full layer buildup can handle 1400°F, but when refractory and other complementing technology is used, the joints can handle over 2000°F.
